# Costa da Caparica Artificial Sand Nourishment and Coastal Dynamics

VELOSO-GOMES, F., COSTA, J., RODRIGUES, A., TAVEIRA-PINTO, F., PAIS-BARBOSA, J., and DAS NEVES, L., 2009. Costa da Caparica Artificial Sand Nourishment and Coastal Dynamics. Journal of Coastal Research, SI 56 (Proceedings of the 10th International Coastal Symposium), 678 – 682. Lisbon, Portugal, ISSN 0749-0258

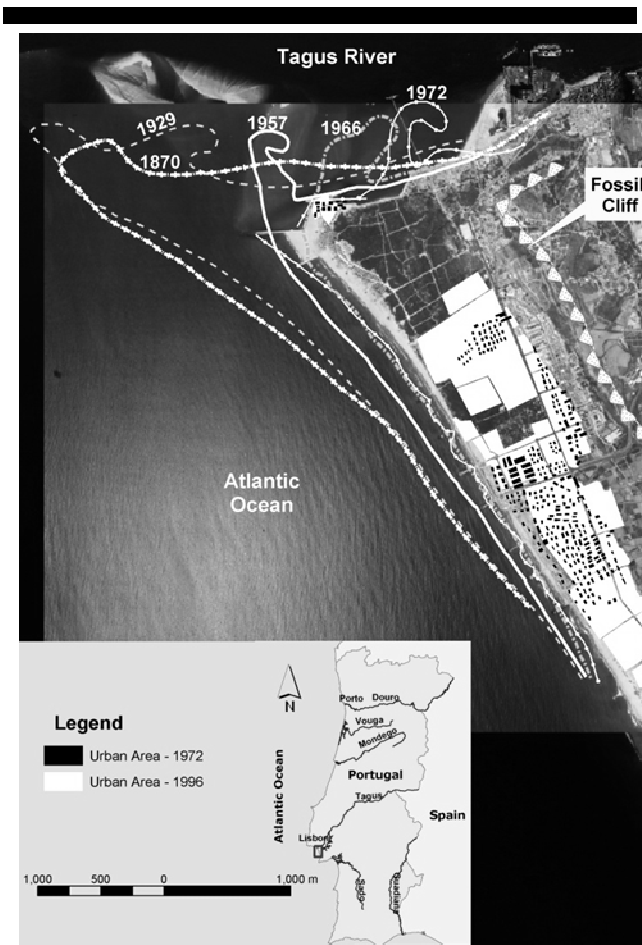
Figure 1. Cova do Vapor – Costa da Caparica coastline and urban area evolution.

The coastal stretch between Cova do Vapor – Costa da Caparica, located on southern bank of the Tagus river inlet (Figure 1), started a new cycle of coastline retreat in the winter of 2000/2001 with serious erosion and overwashes on S. João beach and on the fore dune. Several small emergency works were carried out during the 2002/2003 and 2003/2004 winters to minimize storm damage.

Besides erosion, this area is subjected to significant urban and tourism pressures that cause extra difficulty for coastal zone management. As illustrated in Figure 1, the urban area increased considerably between 1972 and 1996, and there are proposals for new developments.

From a geological perspective this area is composed of alluvium deposits (coastal plain) formed through the interaction of the sea and Tagus river flow regimes. Along the coast ca. 1.5 km from the coastline there is a scarp slope known as the fossil cliff of Costa da Caparica (Figure 1) ca. 70 m in height. This important feature will act as a natural buffer barrier in case of erosion, or in case of sea level rise on a geological scale (VELOSO-GOMES *et al.* 2004).

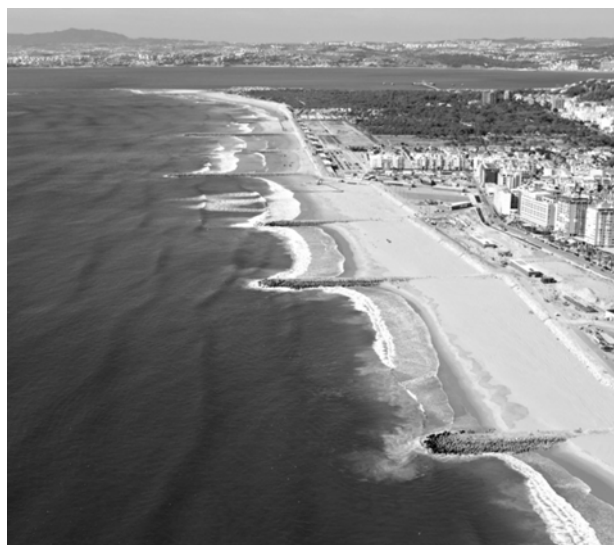
Figure 4. Costa da Caparica sand nourishment (9<sup>th</sup> October 2008).

The beach sand nourishment close to the coastal defence structures (Figure 4) is moving seaward, adjusting the bottom profiles to the local wave climate and tide actions.
